Service Bulletin
Y	For Factory Service Release Only	Product: ScanIR II	Service Bulletin No.: SB-S2-001
Y	For Field Service Release Only	Issue Date: 27 Feb 2004	Page 1 of 3
Y	For External Release

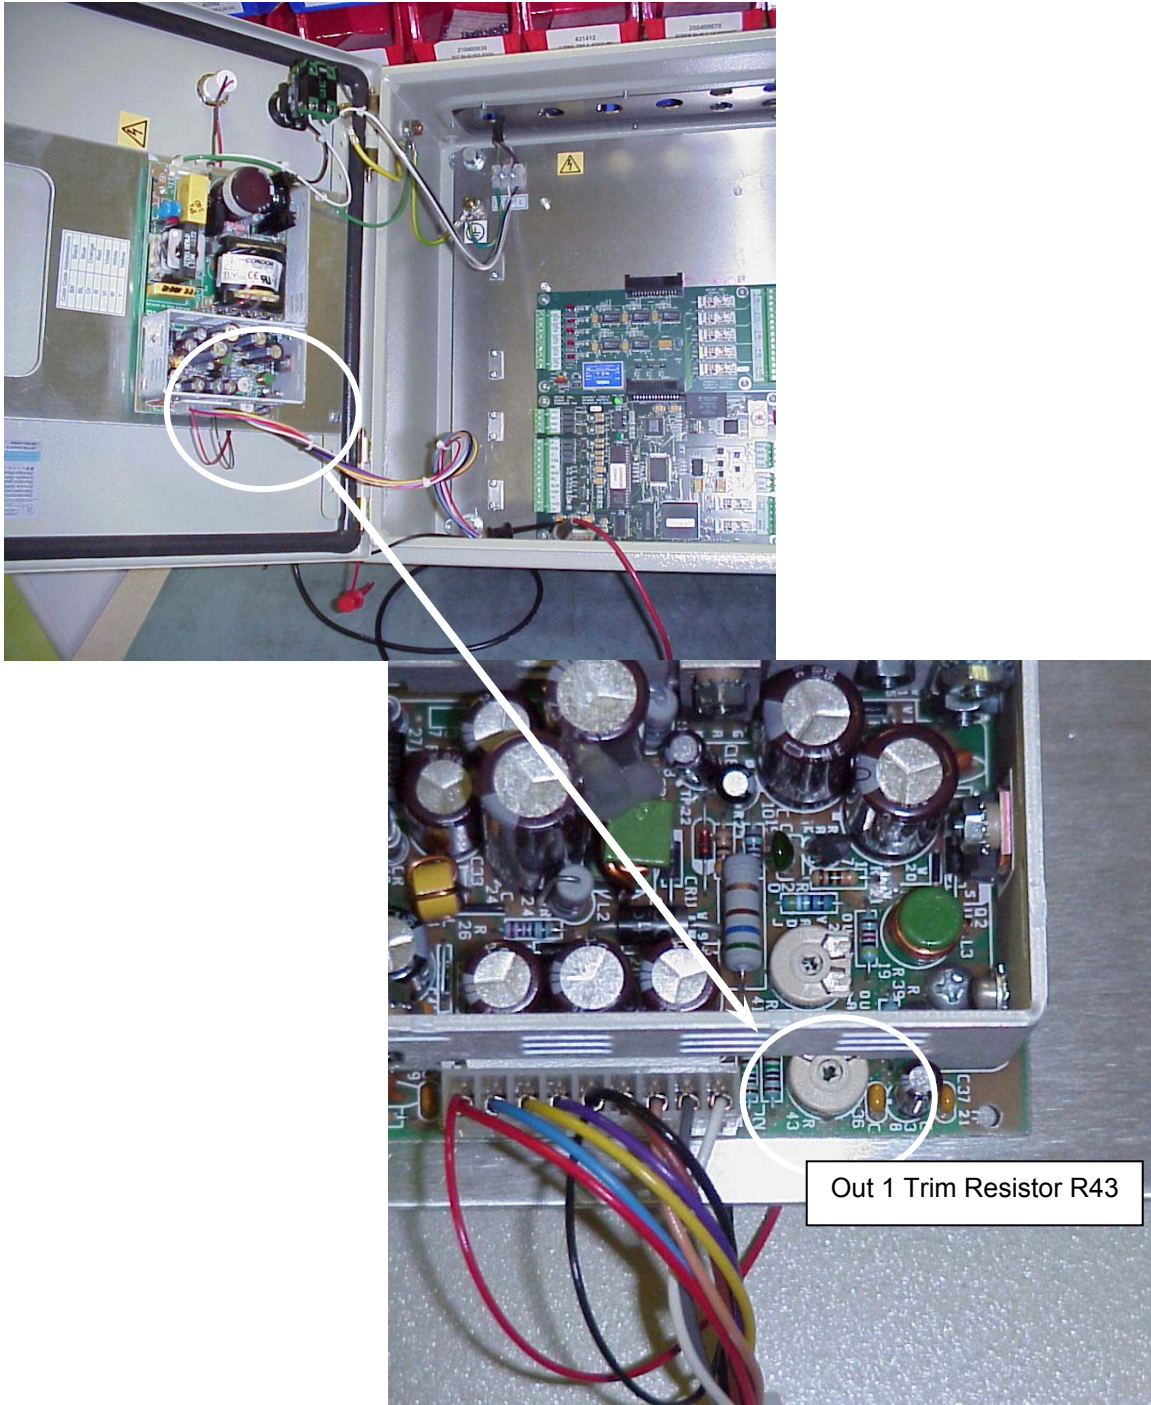
Exhibit #2

This condition has been traced to the voltage setting on the switching power supply. The supply is supposed to come to Ircon from the supplier's factory preset to 5 volts. However, several ScanIR II units have been found with settings of 4.8 volts. Contact corrosion and temperature drift can cause the supply voltage to drop even lower during operation. Lower power supply voltage settings may cause more frequent "No Communications" alarms, possibly even shutting down the system and not restarting at all.

The combination of low power supply voltage levels and spikes of up to 200 millivolts from digital logic can cause the voltage to dip below the threshold of the automatic system reset circuit. Readjusting the power supply to 5.15 volts will make the ScanIR II system more tolerant of these environmental conditions and ought to eliminate false communication and reset problems.

- A. With ScanIR II already powered-up and running, measure the voltage between JP100 pin 3 and TP 100. See Exhibit #1.
- B.
- C. If the reading is less than 5.15 volts, adjust the Out 1 Trim resistor R43 on the switching power supply by turning clockwise until the measurement indicates 5.15 volts. See Exhibit #2.

Caution: Exercise care when adjusting in a counterclockwise rotation to lower voltage! Adjusting too far can cause a communication failure and a system reset. If done on a customer's system while in use, a system reset could cause interference with the customer's manufacturing process.
