# Endurance Firmware Update for disable EAAA

- In special cases where EAAA can't be eliminated at installation location, please use the firmware 2.03.10\_2.02.34
- The 2.03.10\_2.02.34 is suitable for all 2 color (Ratio) units.
- To disable EAAA please use this SOP (Standard Operating Procedure).
- Hardware needed
  - Ratio Sensor
  - Endurance Ethernet Cable
  - Laptop/PC
- Software needed :
  - DTMD v6.1.99
  - Terminal7
  - Firmware file : "Endurance Device Firmware\_02.03.10\_02.02.34.fw"

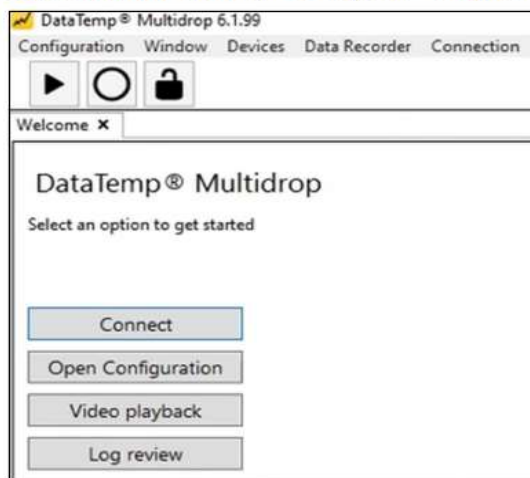
1. Connect the Endurance sensor to the computer. Make sure that sensor and network adapter of the computer are in the same network.
2. The DataTemp Multidrop software is provided as zip file. Unzip that file. Go to the unzipped folder, search for the "Multidrop.exe" file and double click on it. The DataTemp Multidrop software is not installed, the application opens immediately.
3. Click on the button <Connect> to get started.

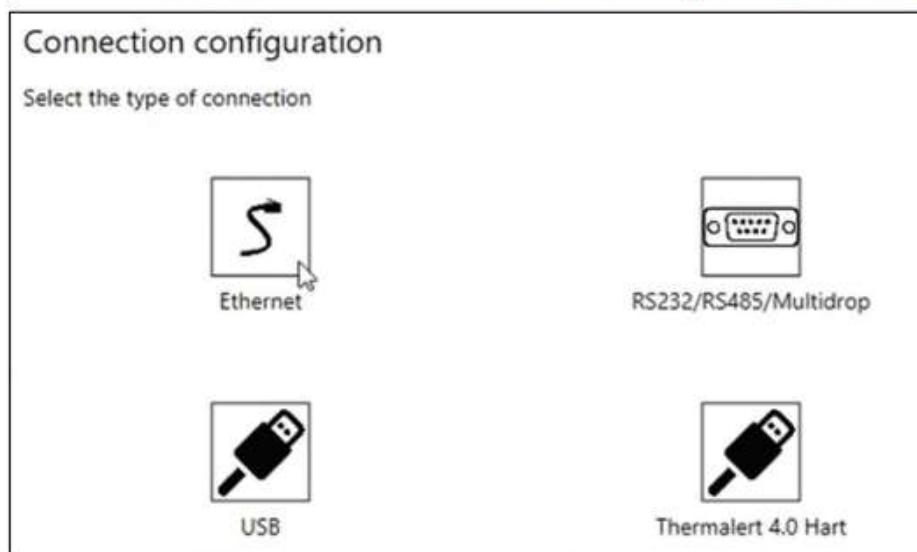
4. Click on the icon <Ethernet> as the required communication type.

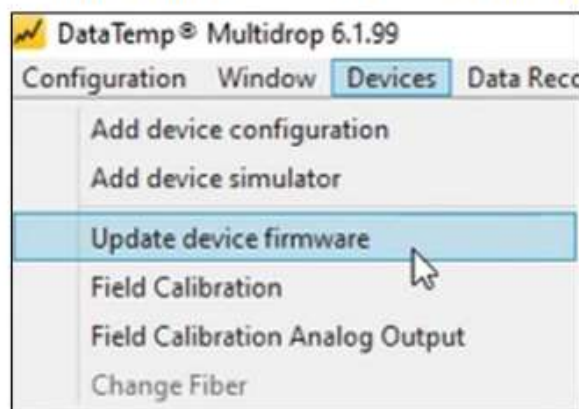
6. Call the menu <Devices> and then launch the submenu <Update device firmware>.

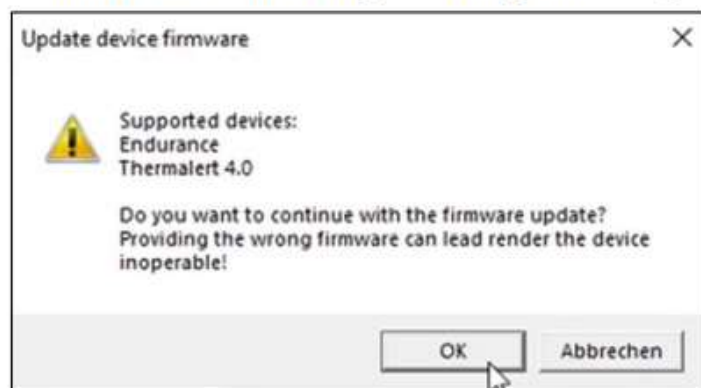
7. Confirm the following warning message.

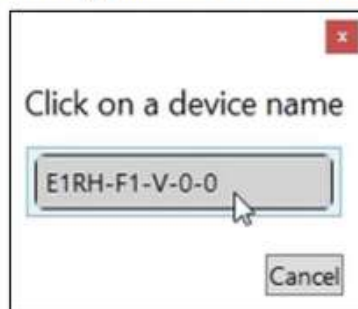
8. In case there are several devices in the network, a list appears in the following dialog box. Click on the desired device to be updated.

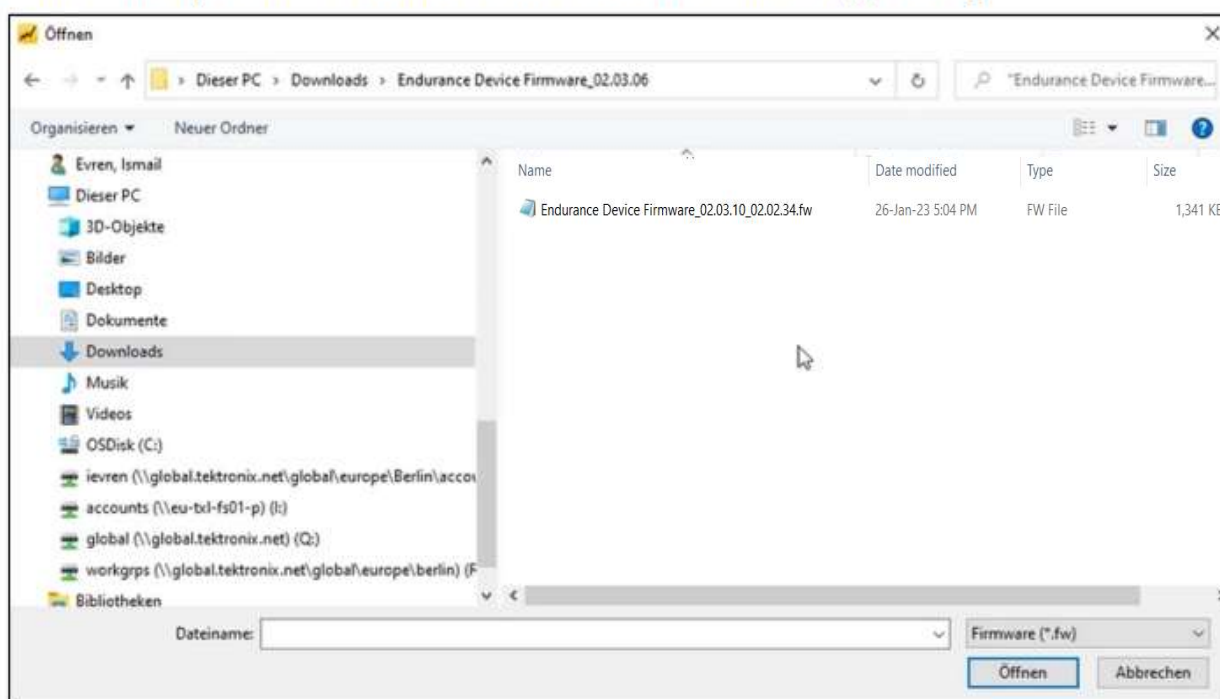
9. Select the provided firmware file via the following dialog box.

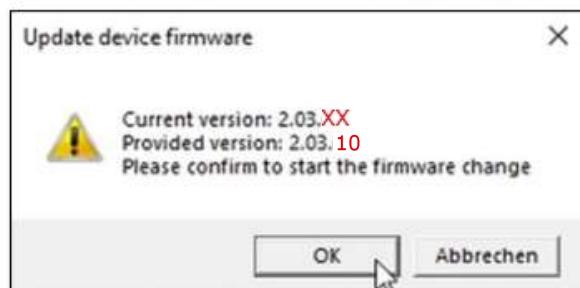
10. The software checks the firmware version installed on the sensor with the version to be installed.

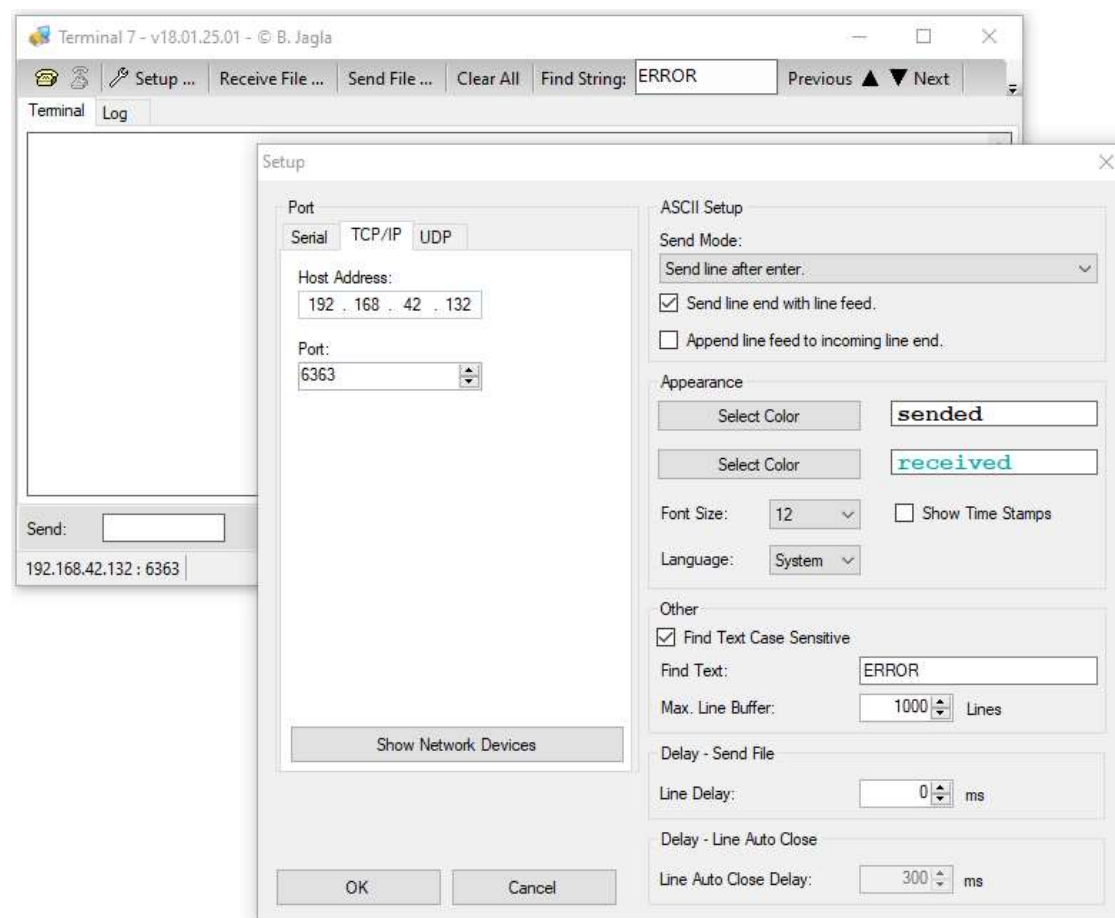
14. Open the Terminal7 program and click on setup

15. Type the IP address and click on OK

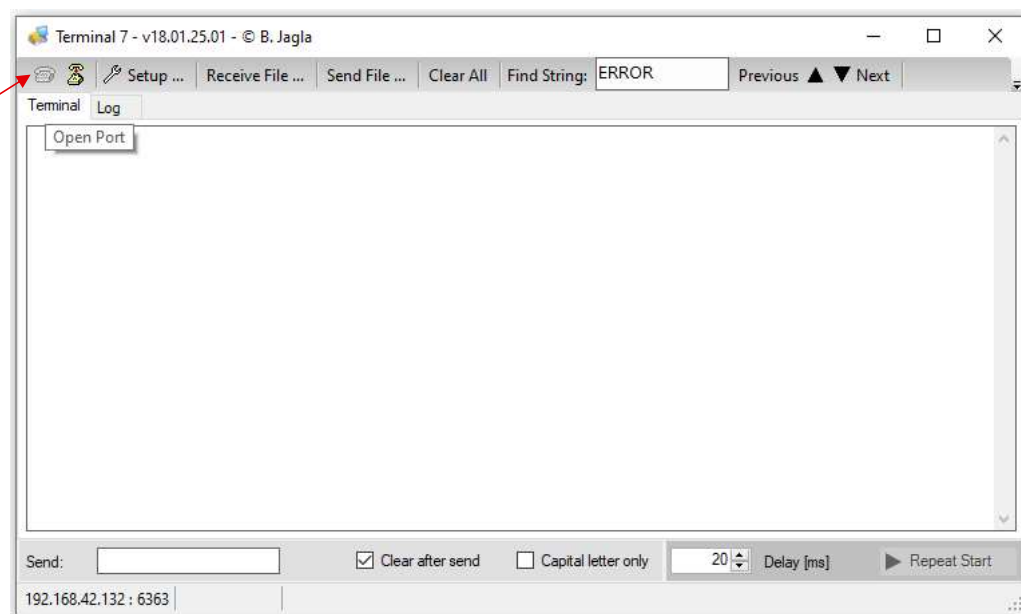
16. Click on Open Port, if communication with Endurance correct you won't get error message.

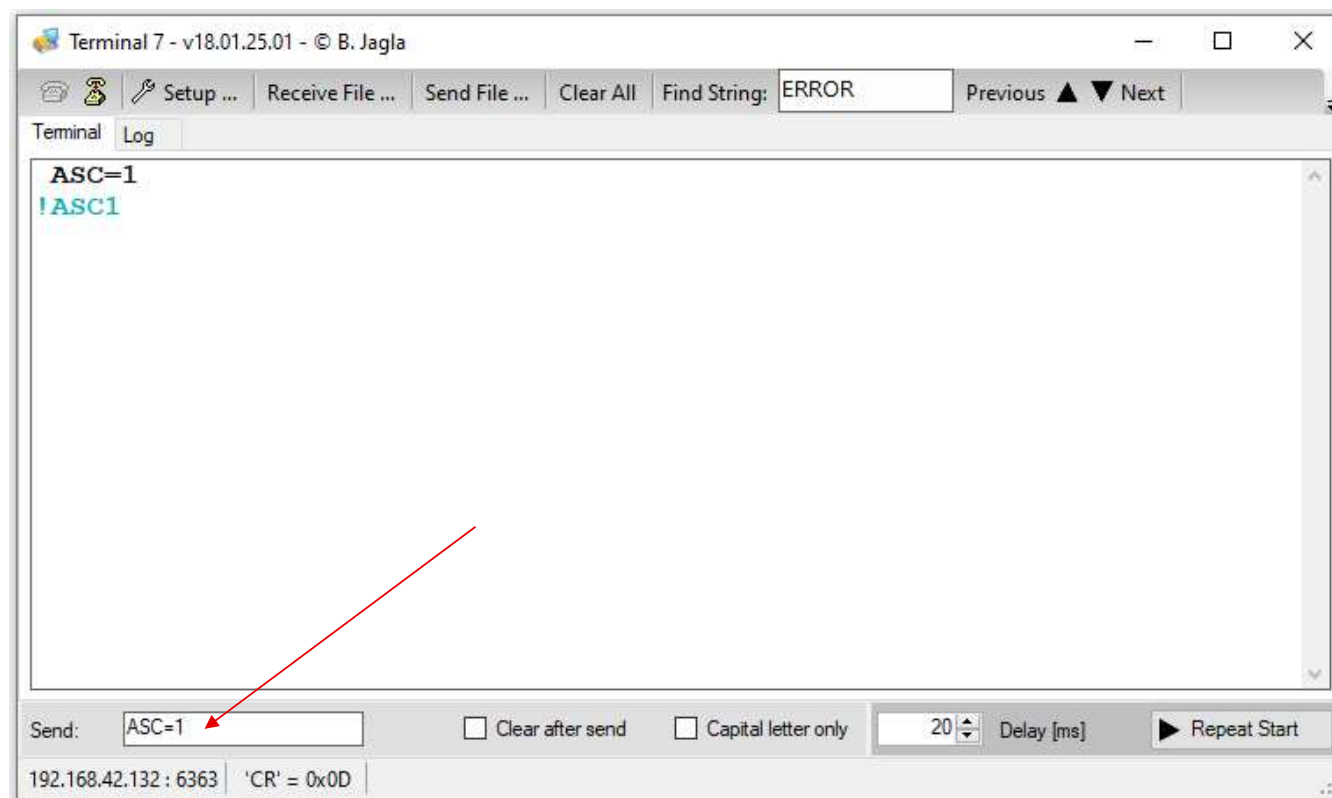
17. Type **ASC=1** in Send space and press ENTER from keyboard

Once Endurance accept the command, you will get reply from Endurance in Blue letter.

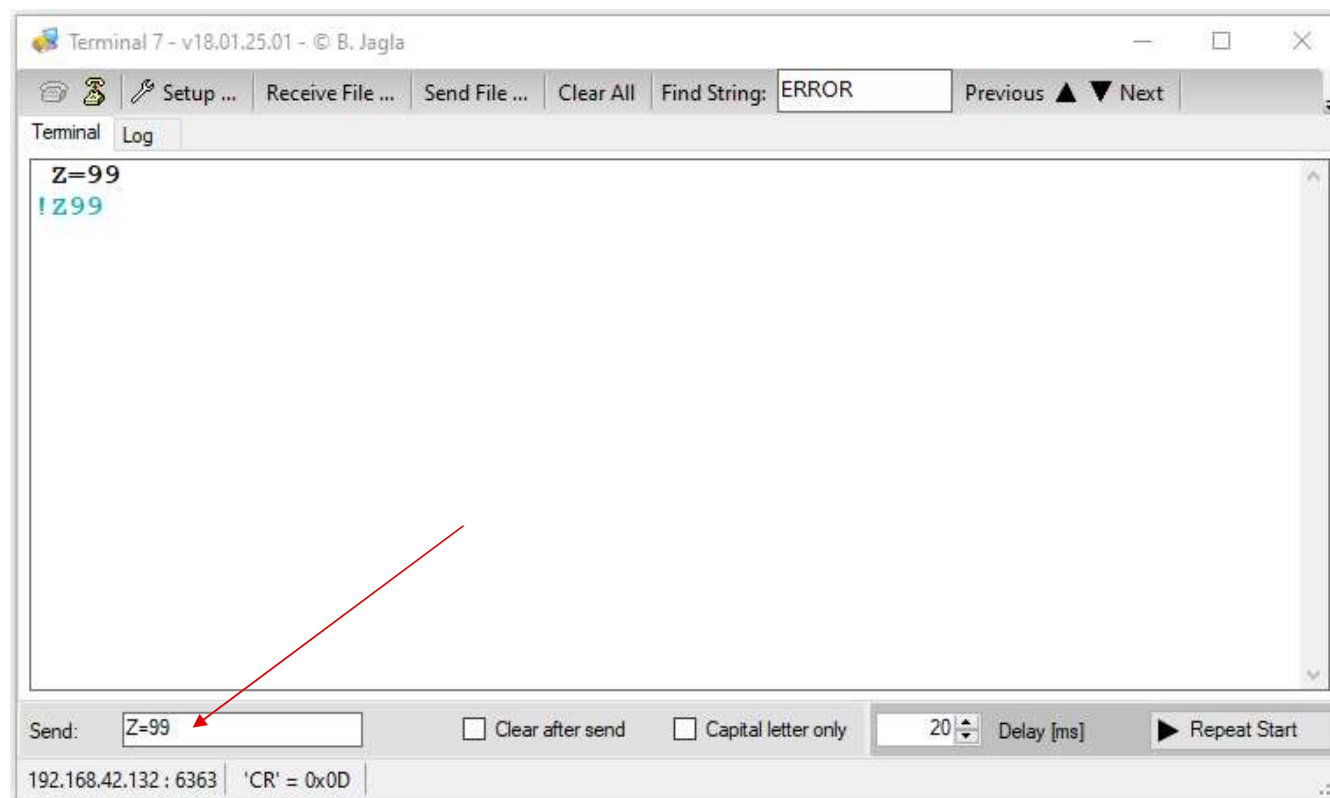
18. Type **Z=99** in Send space and press ENTER from keyboard

Once Endurance accept the command, you will get reply from Endurance in Blue letter.

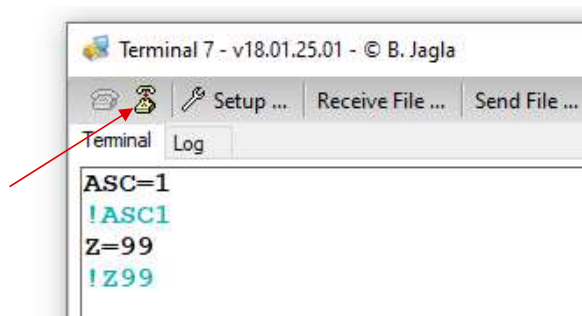
19. Click on Close Port and close the Terminal7
